# Manhole Inspection Summary

Manhole # S06AA2015MH

Insp Date: **6/23/06 2:08 PM**

**Location** Address: **3930 FALLSTAFF RD**

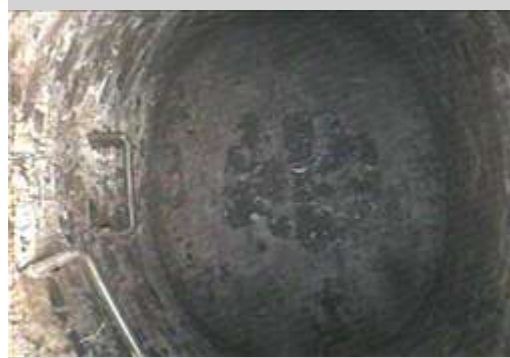
Top View

Adjustment, Corbel, and Barrel infiltration. Channel debris.

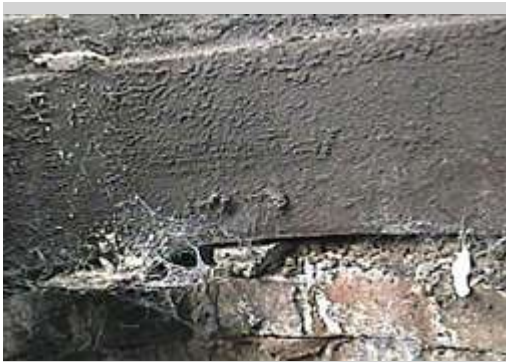
Defect

Frame leaks. Adjustment deterioration, Adjustment infiltration.

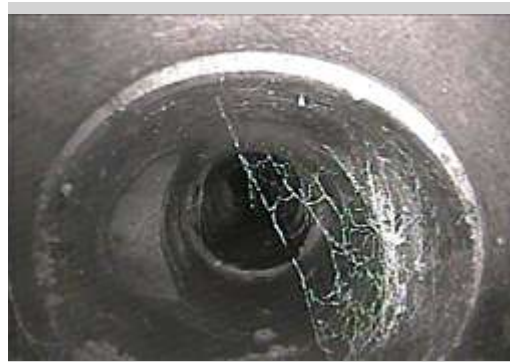
Defect

Pipe Offset

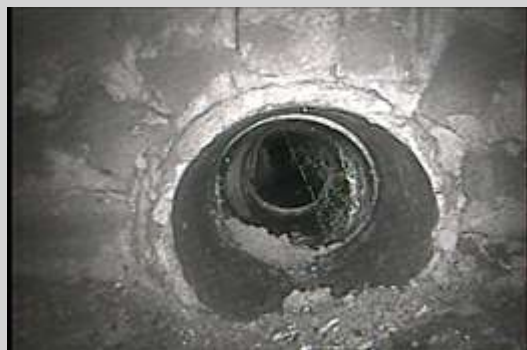
Pipe Out @ 12 O'Clock

8 in. Circular Gravity Sewer

Deposits: ☐ None ☐ Mud ☐ Sludge ☒ **Debris** ☐ Grease

Silt Depth: **2** (in.)

Deposits Extent: **Light**
